Manhole Inspection Summary

Manhole # S04GG2009MH

Insp Date: **7/19/06 9:57 AM**

Location Address: **3302 FALLSTAFF RD**

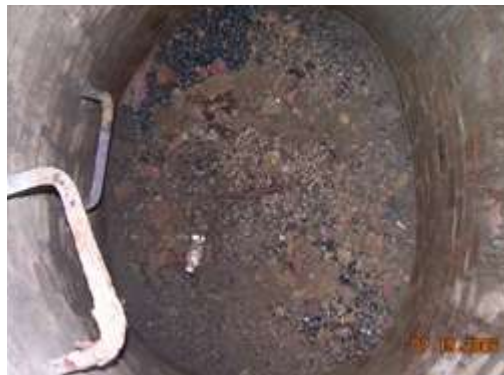
Top View

Adjustment and Barrel infiltration.
Corroded steps. Channel debris.

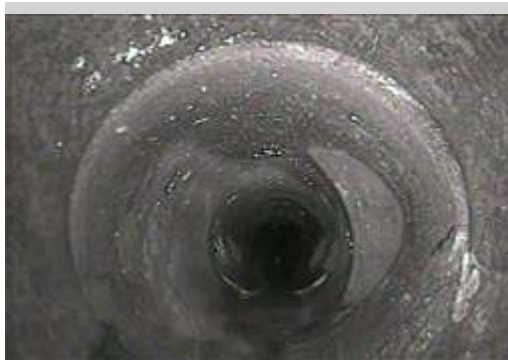
House connection inside the O12

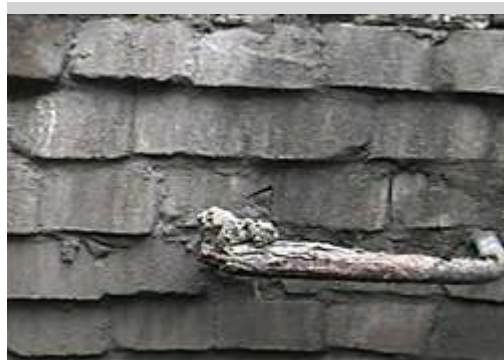
Defect

Corroded step

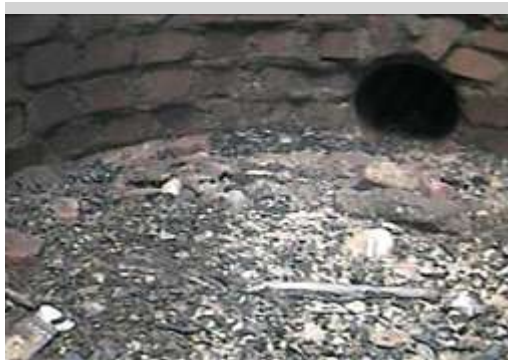
Defect

Barrel deterioration and infiltration.
Channel debris

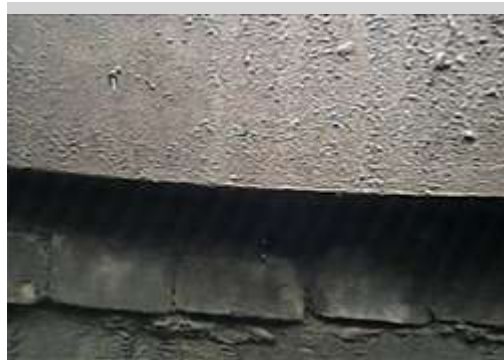
Defect

Frame leaks. Adjustment deterioration
and infiltration.

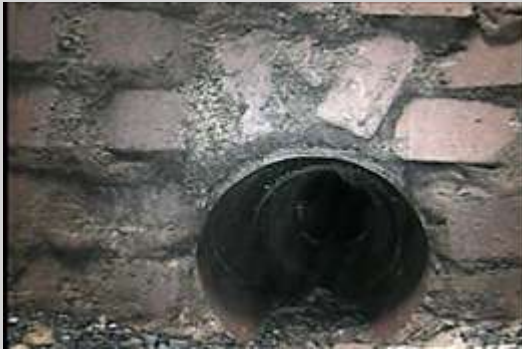
8 in. Circular Gravity Sewer
Pipe Out @ 12 O'Clock

Comments **The O12 pipe picture shows Barrel infiltration.**

Deposits: ☐ None ☐ Mud ☐ Sludge ☒ **Debris** ☐ Grease

Silt Depth: **0.5** (in.) Deposits Extent: **Light**
